## Comprehensive Watershed Improvements in Laolao Bay, Saipan, Commonwealth of the Northern Mariana Islands

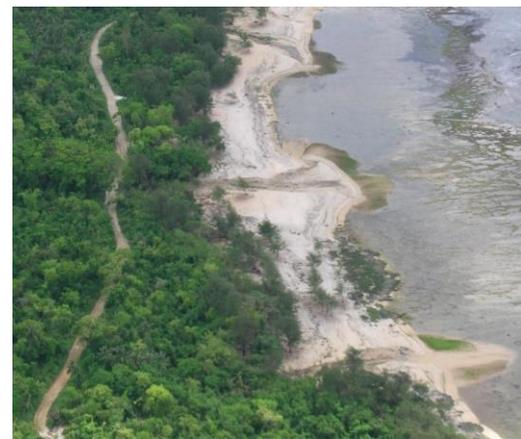
Sedimentation stream outfalls prior to restoration project (2004) © Tim Lang

The upland area of the watershed is a mix of residential lots (many of which have septic systems), a golf course, and agricultural and other private land uses. As a result, the bay is subject to erosion and runoff pollution from unpaved roads, unpermitted development, land clearing, and agricultural practices. Heavy rain events exacerbate the problem as stormwater carries soil and pollutants into the bay. Land-based pollution from upland watersheds has resulted in excess nutrients and macroalgae in Laolao Bay.

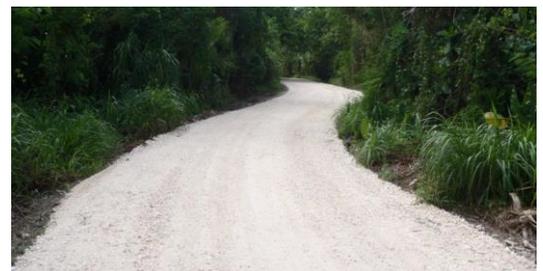
Section of road grading work completed by DPW © Tim Lang

The paving of 0.4 miles of Laolao Bay Drive was completed in April 2012. The new drainage system includes a curb and catch basin system, subgrade drain pipe, concrete sediment chamber, and a gabion sediment chamber. A total of 1.9 miles of unpaved parts of Laolao Bay Drive and Gagap Road were regraded utilizing techniques learned from workshop training. Six stream crossings were constructed of reinforced concrete fords and included rip-rap slope protection.
